パキスタンにおける防災知識 の伝承と普及活動報告

小長井一男

Quick Report of the JSCE Mission for Geotechnical Survey along Jehlum and Kunhar Valleys (Ver. 1.1)

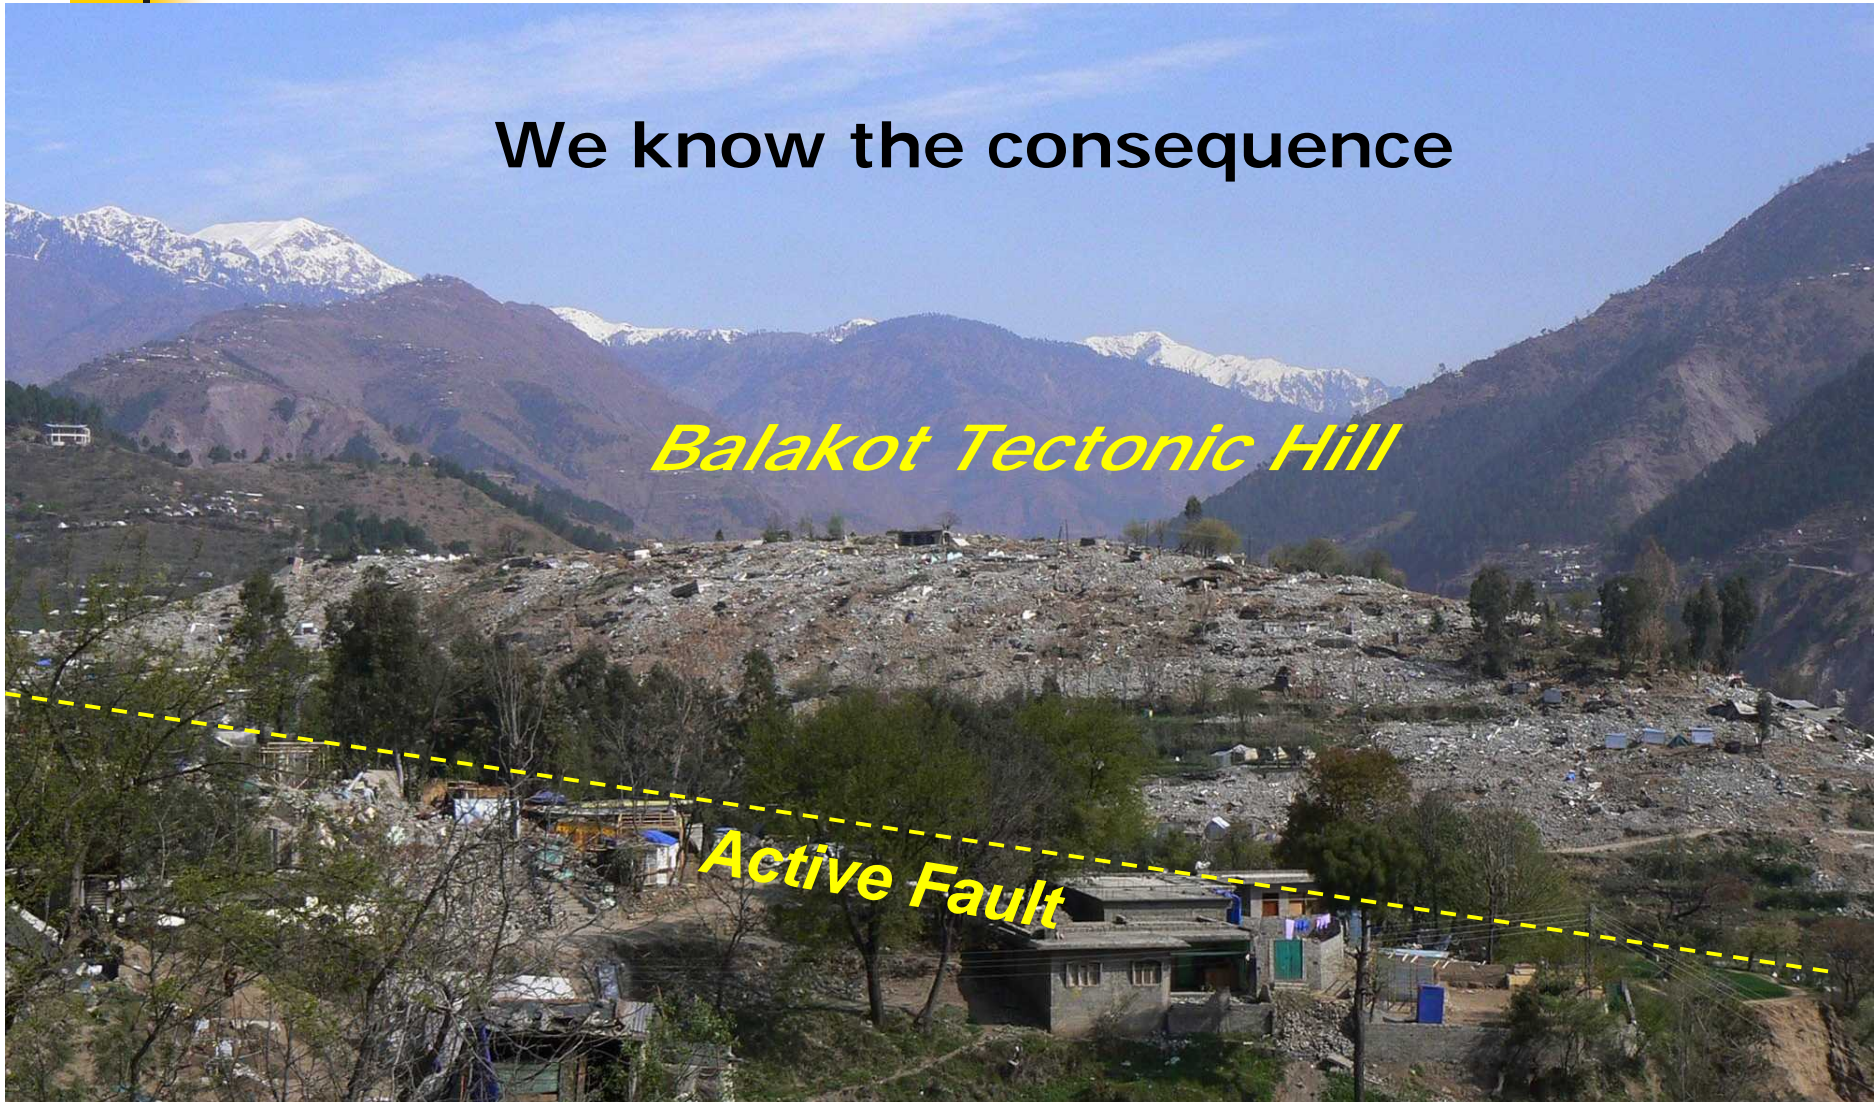
Geomorphology can tell where an active fault is!

Balakot Tectonic Hill

Active Fault

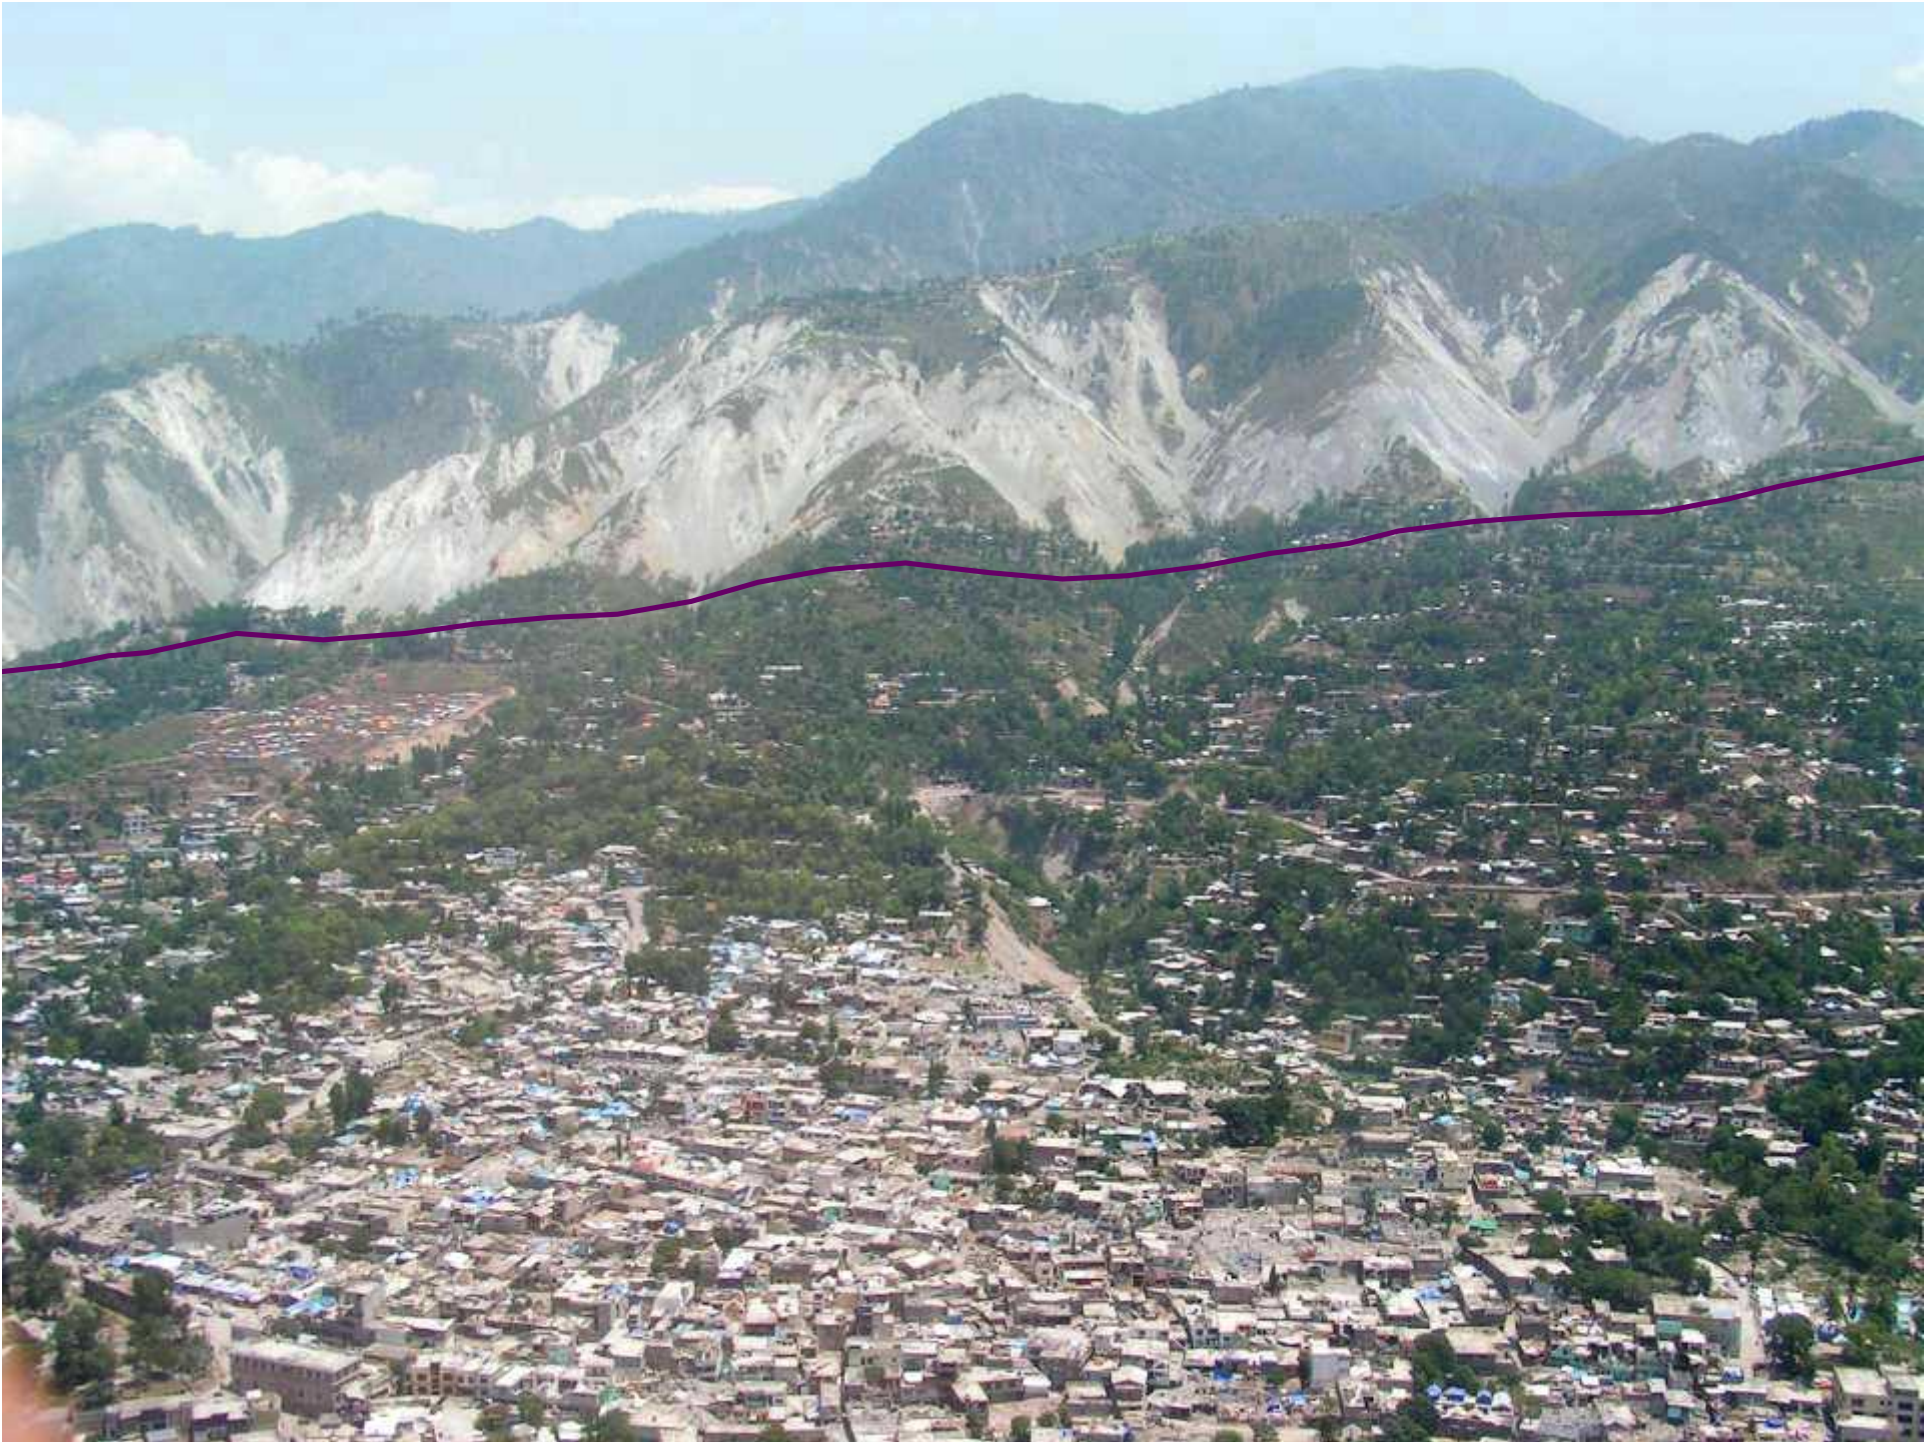
Debris sources behind the city

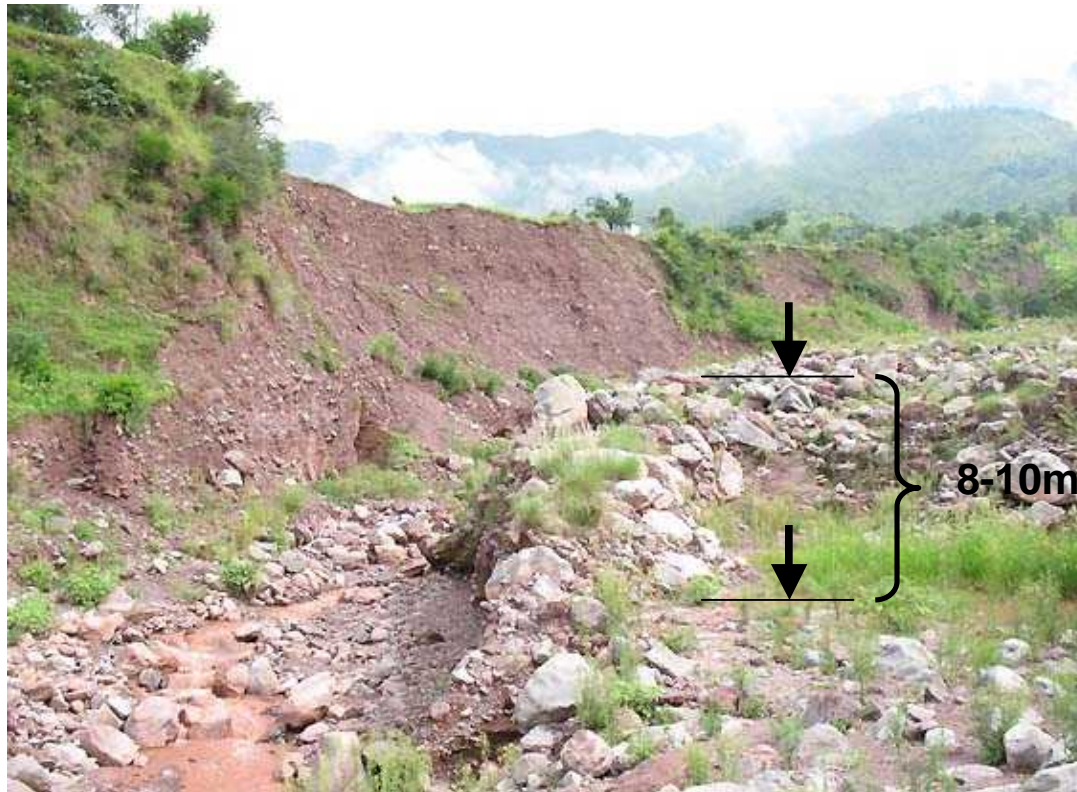
Remaining front of debris flow

- (N34°20' 37.8", E73°30' 57.6")

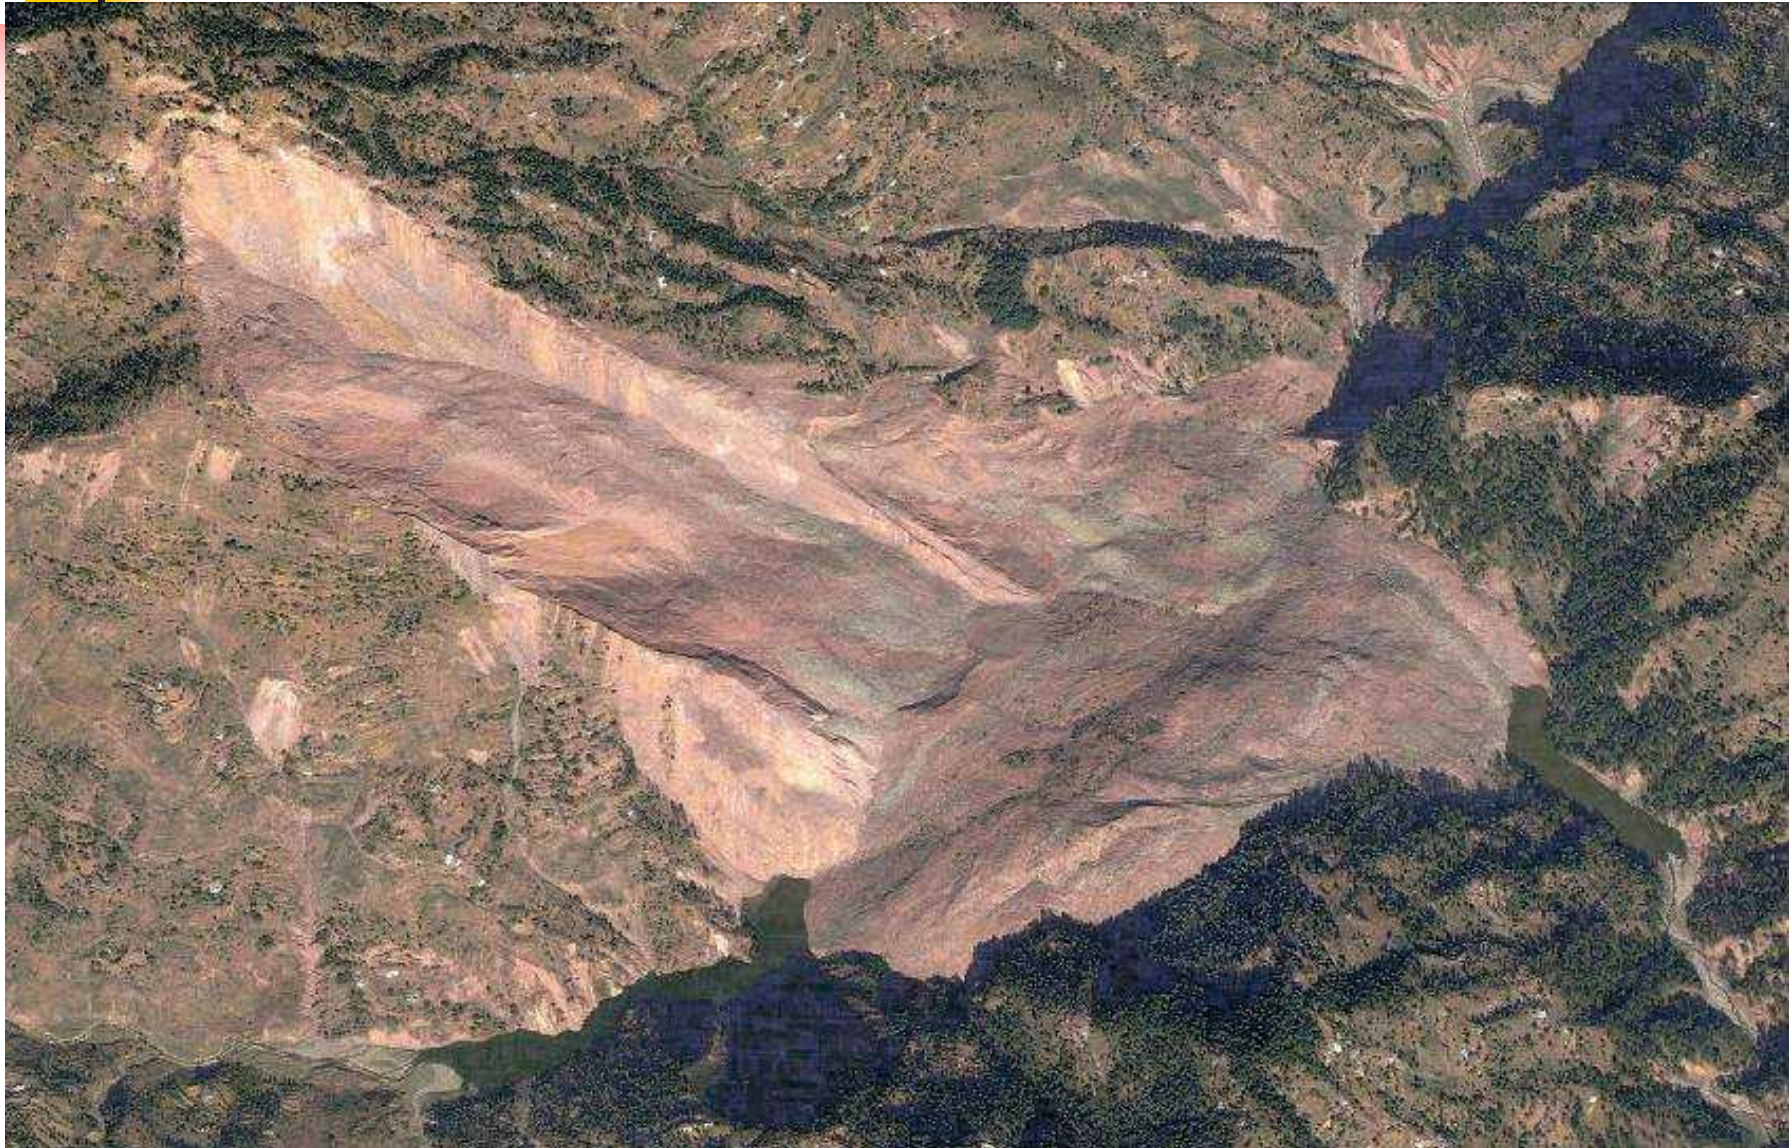
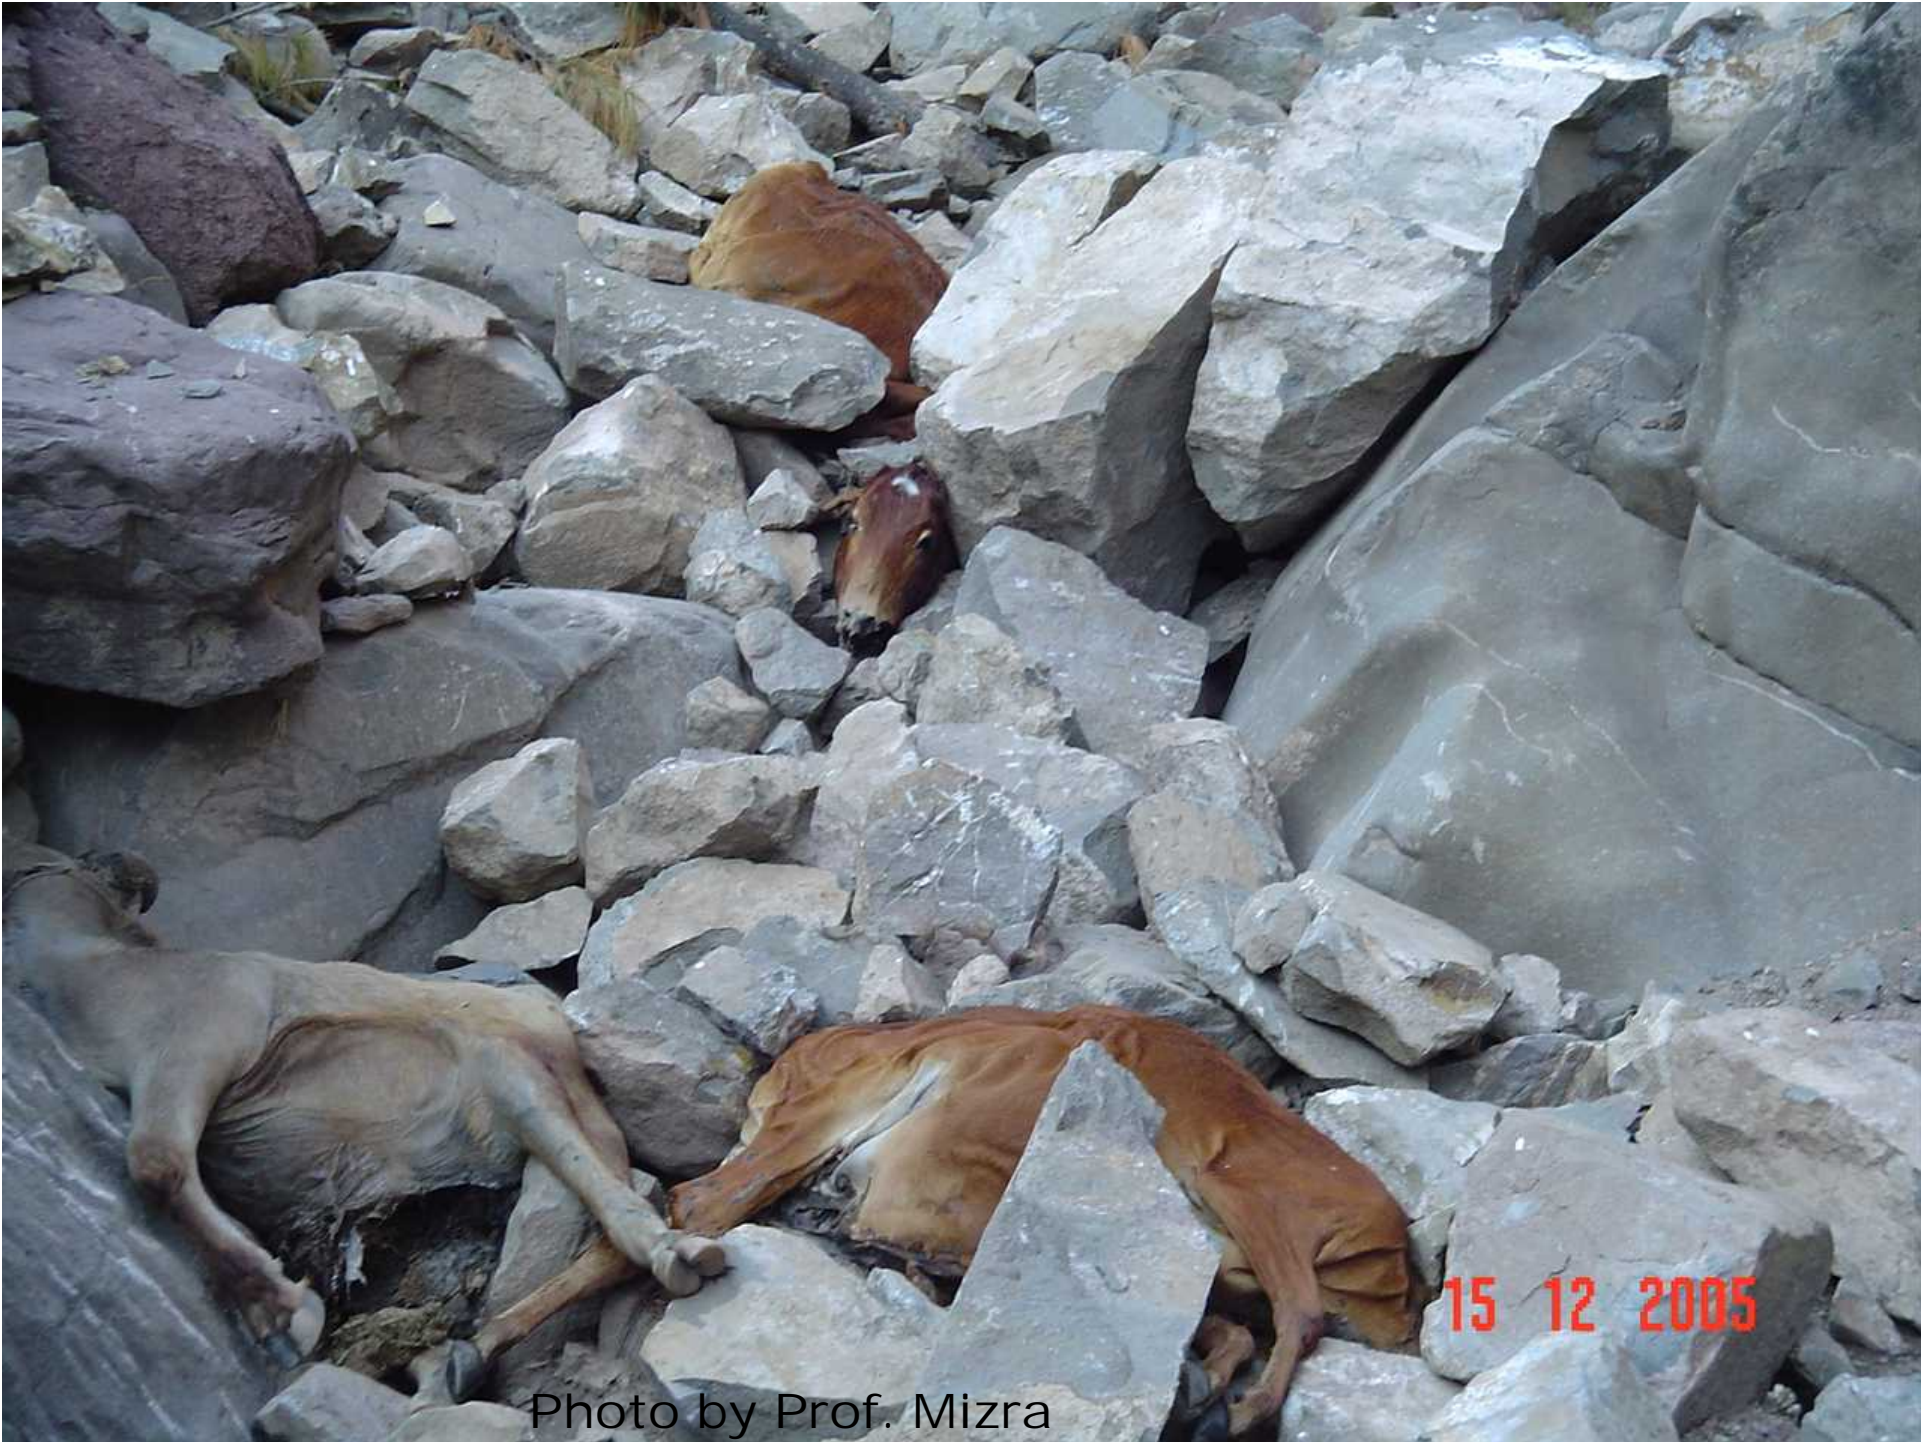
Hattian Bala rock-avalanche deposit

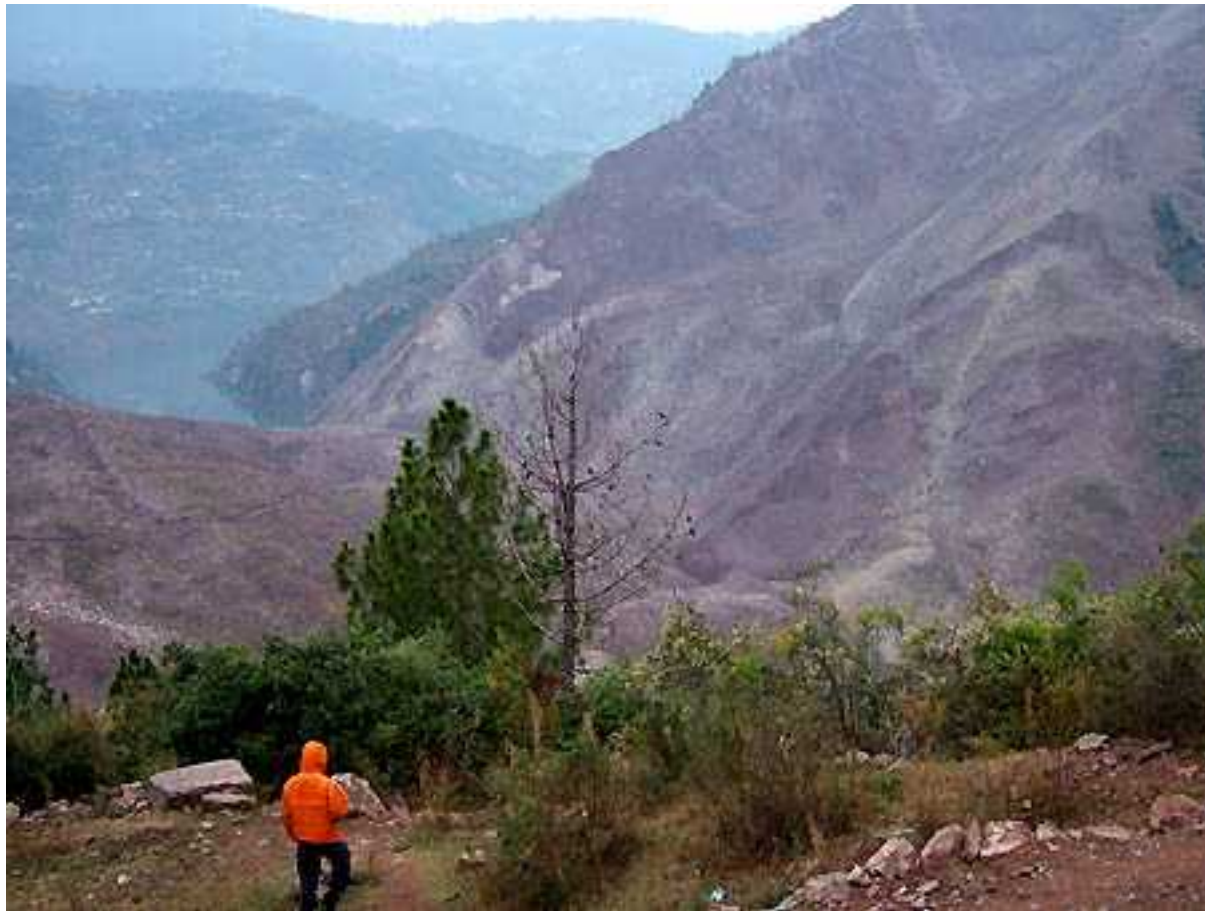
Hattian landslide mass
